Manhole Inspection Summary

Manhole # S19GG2009MH

Insp Date: **4/24/07 12:56 PM**

Location Address: **1118 BELLEMORE RD** Cross Street: **HARRINTON RD**

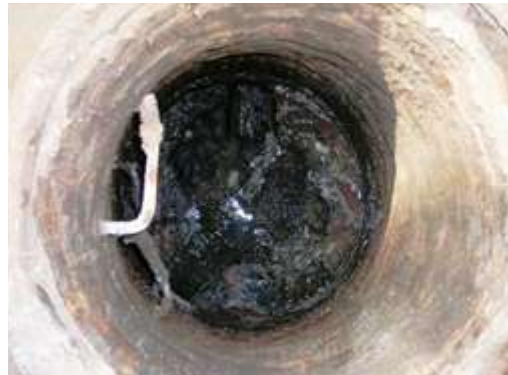
Top View

Evidence of surcharge - Bench debris.
Channel debris.

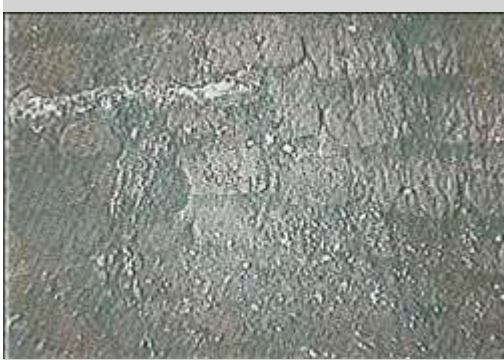
Evidence of surcharge

Barrel deterioration and infiltration.

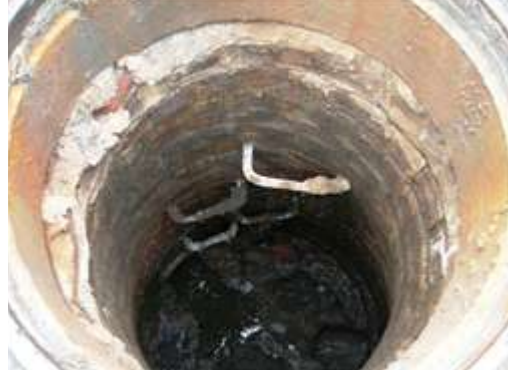
Defect

Frame leaks. Frame offset. Adjustment
deterioration, loose brick and infiltration.
Corbel and Barrel infiltration.

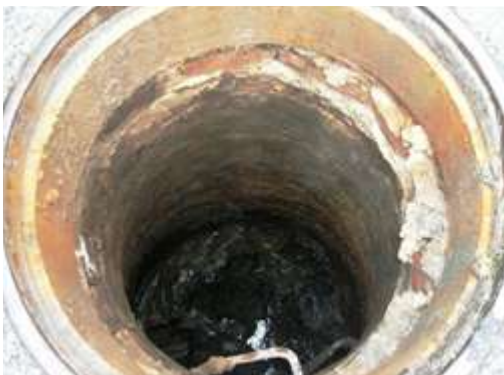
Defect

Frame leaks. Frame offset. Adjustment
deterioration, loose brick and infiltration.
Corbel and Barrel infiltration - other side.

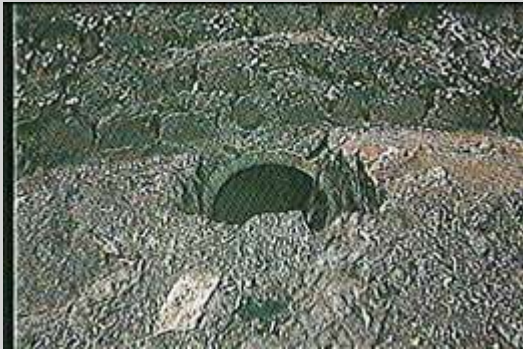
Pipe Out @ 12 O'Clock

Barrel deterioration and infiltration.

Deposits: ☐ None ☒ **Mud** ☐ Sludge ☒ **Debris** ☐ Grease

Silt Depth: **1** (in.) Deposits Extent: **Light**

Infiltration: **None** Pipe Seal Cond: **Roots**
